REPORT OF THE DIRECTOR  
BUREAU OF SAFETY

ACCIDENT ON THE  
PENNSYLVANIA RAILROAD

BAY VIEW, MD.

INVESTIGATION NO. 2175

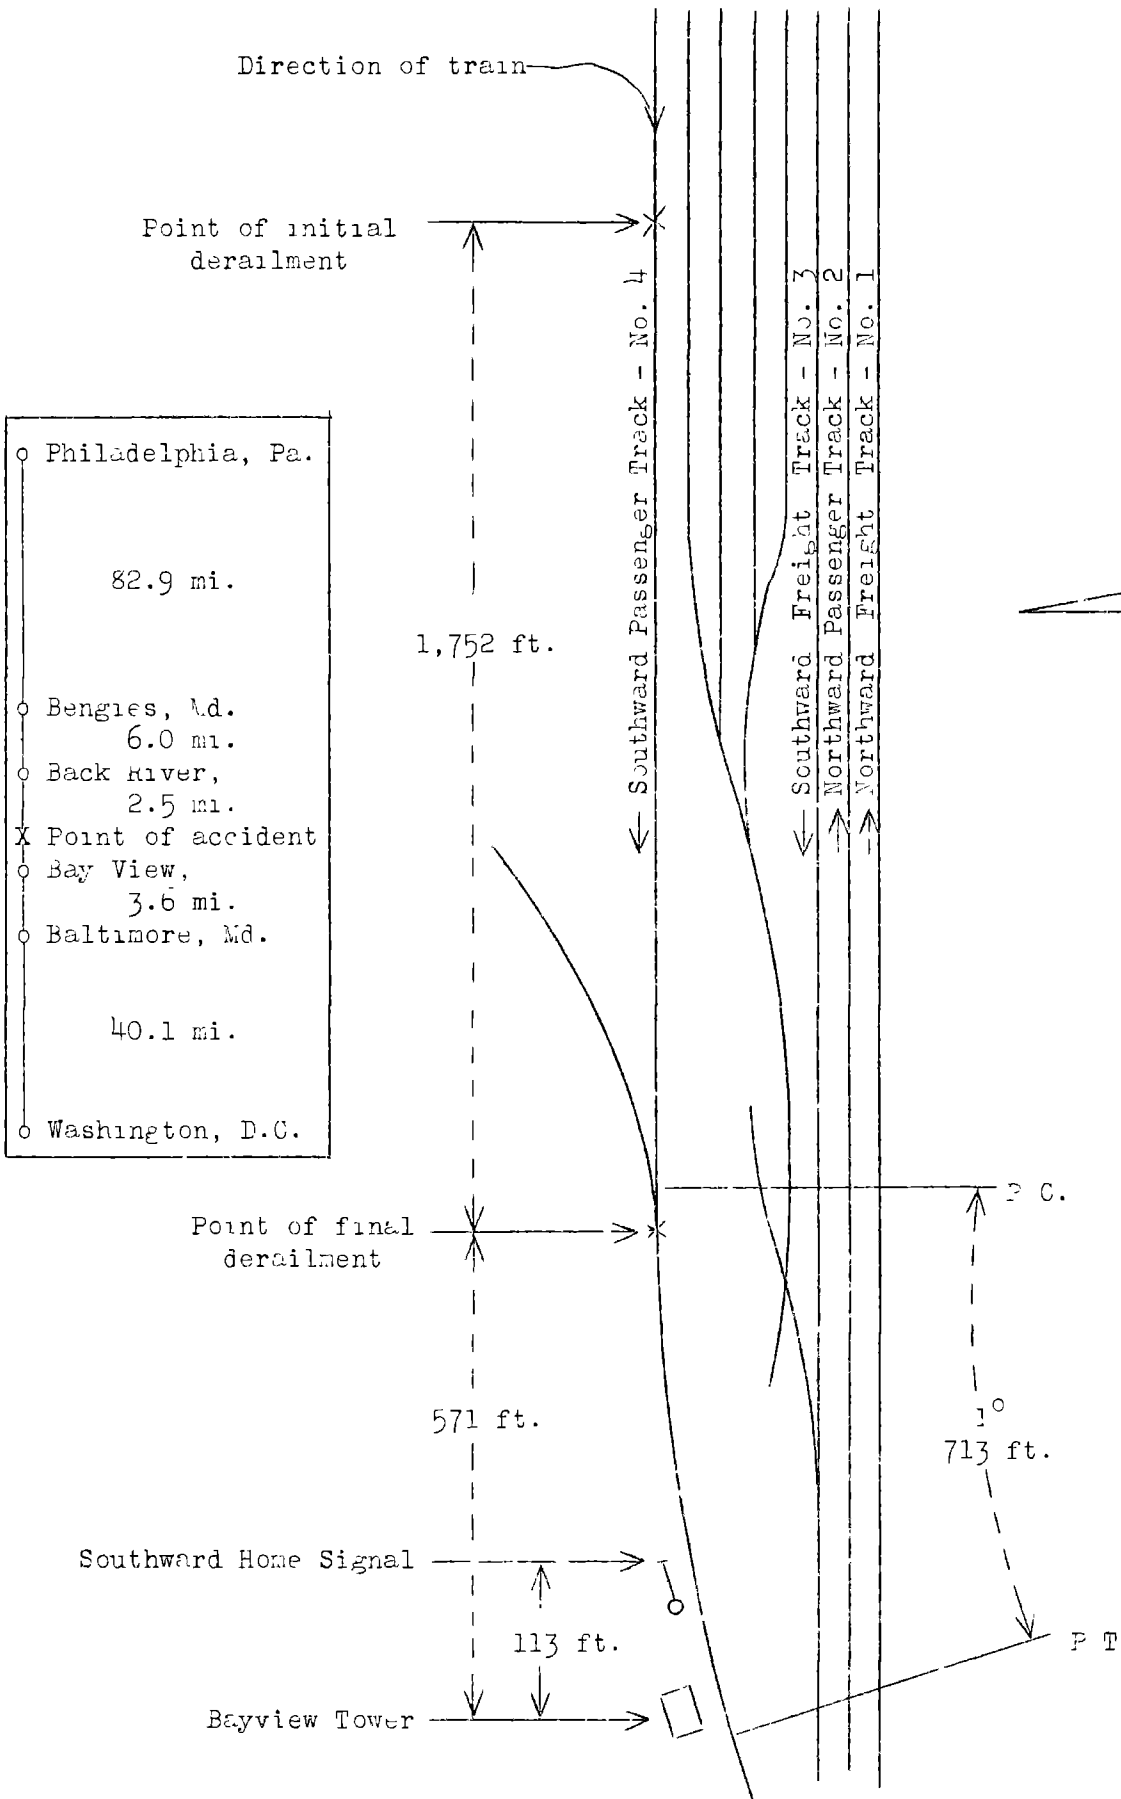
Inv. No. 2175  
 Pennsylvania Railroad  
 Bayview, Md.  
 May 28, 1937

Inspection of the track showed the first mark of derailment to be a light flange mark on a tie plate at a point  $6\frac{1}{2}$  inches east of the gauge side of the west rail. Proceeding southward at a slight angle toward the east, this mark appeared on top of each tie for a distance of  $90\frac{1}{2}$  feet growing heavier as it progressed and at that point it was 18 inches east of the gauge side of the west rail. From there it paralleled the rail southward for a distance of 1,661 feet to the

lead rail of the B. & O. interchange track where the final derailment occurred. There was a light skidmark on the top of the west rail extending from the outside of the head at the initial mark of derailment diagonally across the top of the rail for a distance of 51 feet to the gauge side. This mark was evidently made by the lower portion of the truck when the No. 4 journal failed and the wheels became derailed. At a point 54 feet south of the initial mark of derailment a very light flange mark on top of the tie appeared 14 inches to the east of the east rail, and six other ties similarly marked were found at intervals within a distance of  $142\frac{1}{2}$  feet.

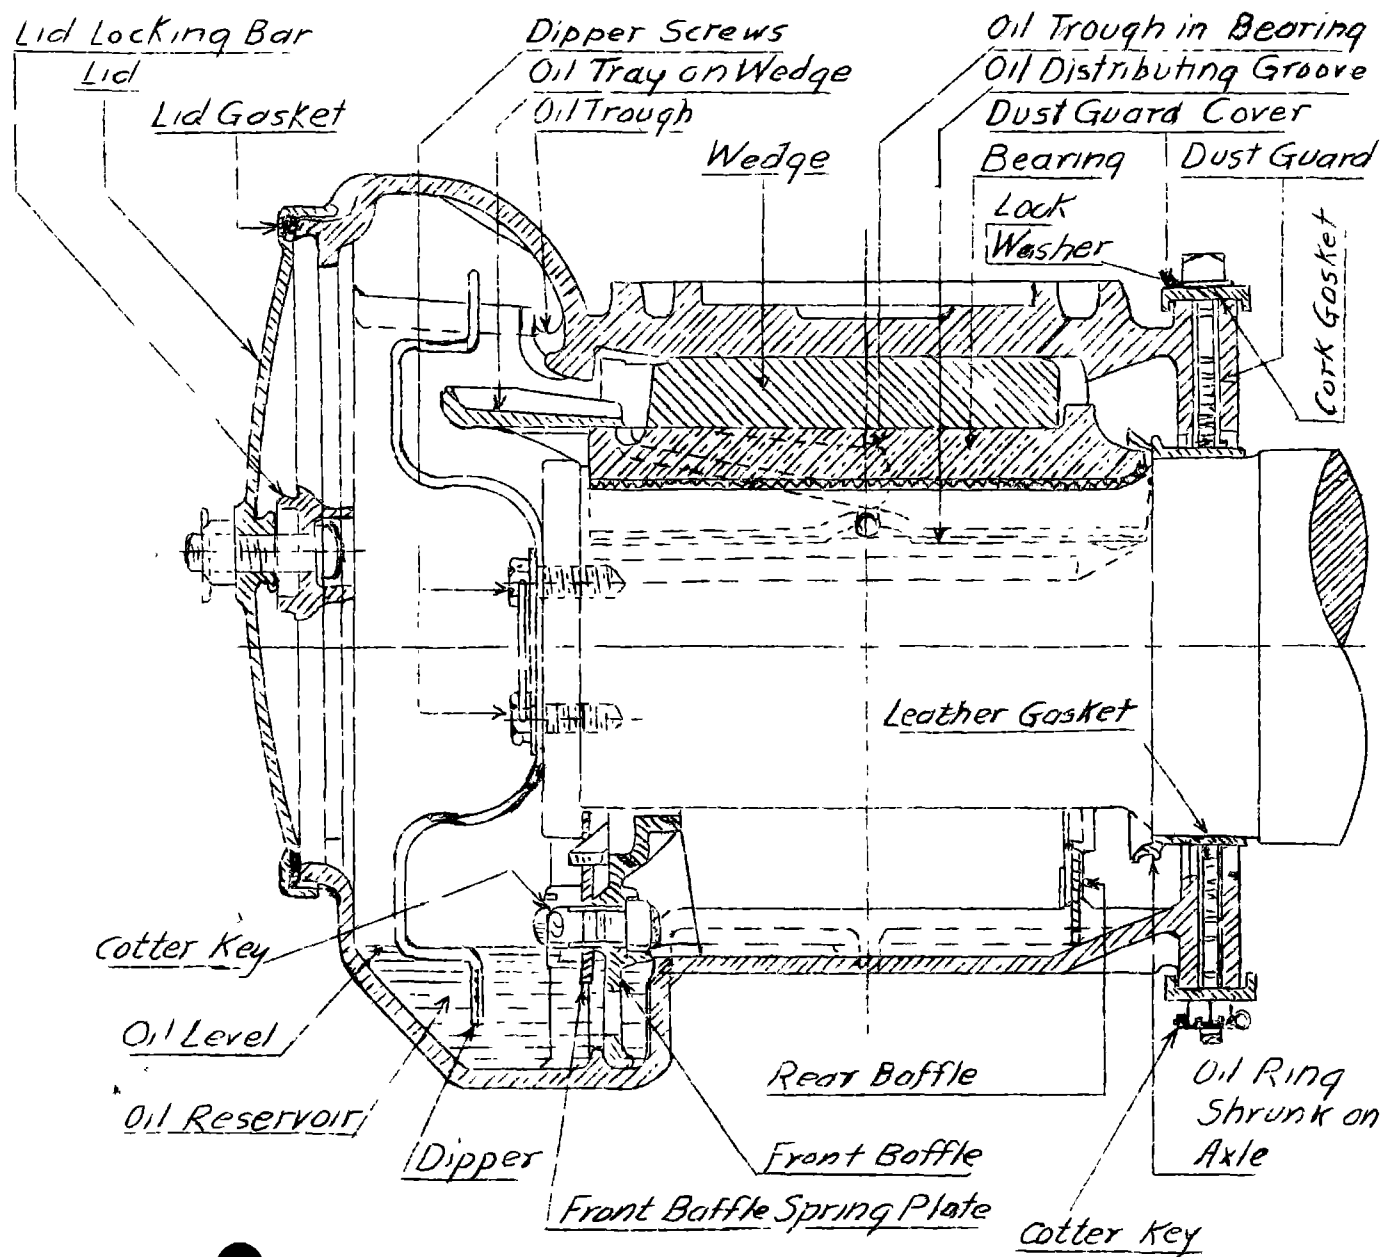
The Isothermos journal box is designed to accomplish lubrication by means of a continuous flow of free oil to the bearing surfaces, thus eliminating the necessity of waste packing; it employs a bearing of the conventional type adapted for use in this particular system. The oil reservoir which has a capacity of about six pints, is located at the bottom of the box and a metal stamping called a dipper, which is securely attached to the end of the journal by two studs, is used to convey the oil to the top of the box. The wedge inserted between the bearing and the top of the box is of the usual type except that a wide lip, called the wedge tray, which extends beyond the end of the journal, is cast on its outer edge to collect the oil delivered to the top of the box by the dipper. The slope of the floor of this tray causes the oil to drain through a hole in the wedge into channels in the top of the bearing which direct the oil to holes on each side of the bearing through which it flows to longitudinal grooves on the underside of the bearing where it is delivered to the journal. The edges of the underside of the bearing are broadly chamfered to form a secondary reservoir for oil held in suspension between the edge of bearing contact and the point of

ISOTHERMOS

JOURNAL

BOX

oil delivery. At low speed the oil carried to the top of the box by the dipper falls from the dipper to the tray, while at high speed the dipper casts the oil to the top of the box from where it drains to the tray. The front of the box is hermetically sealed by a cover plate bolted against a cork gasket, and a filling plug is provided for inspection of the oil level and replenishment of the oil supply. The rear end of the box is sealed against leakage by a steel oil-retaining ring, shrunk on the axle, which by centrifugal force returns any oil reaching it to the reservoir, and by a dust guard which fits closely against the oil retaining ring. Tests made by the manufacturer indicate that with oil at a temperature ranging between 128 degrees and 136 degrees, oil will be delivered to the bearing at the rate of about 50 pints per hour when the speed is 50 miles per hour, and at 80 miles per hour the rate of delivery will be about 92 pints per hour.

Examination of the burned off journal was made by the Commission's inspectors. The journal showed indications of intense heat about  $2\frac{1}{2}$  inches from the fillet end. The stub of the collar-end was burned to a cinder through to the center, while the fillet-end showed signs of being twisted to a cone, beginning at a point  $2\frac{1}{4}$  inches from fillet. The journal brass was badly burned and broken in numerous pieces, and all of the bearing metal was missing. The wedge was badly burned on the inside end, the journal box had fused at the junction of the top and rear wall, and the oil retaining ring had been melted through at the top and was welded to the back wall. There were no indications of cracks in the journal box. The journal box cover was in position, intact, and with cork gasket in place; the oil dipper although slightly bent, was secured to the stub end of the journal. The No. 3 journal brass had the bearing metal worn down to the brass on the inside or fillet-end of the brass a distance  $2\frac{1}{8}$  inches, apparently caused by the shifting of weight to the No. 3 after failure of the No. 4 journal.

A report of the engineer of tests, covering this failed journal, states that the axle was burned off about  $2\frac{1}{2}$  inches from the fillet and showed the typical cone shape characteristic of burned axles. Both the wedge and the bearing were in bad condition as the result of heating and pounding, but it was evident that both had been in their proper positions before the accident. There was only one oil hole in the portion of the bearing still left, but this hole was still open. The dipper was slightly bent, but the wreck crew had found it in place with the retaining wire through the bolt heads. It is evident that the condition of the dipper had no responsibility for the accident. The oil retaining ring and the dust guard were destroyed; the journal box had a hole burned in the top by the axle; the cork gasket of the front lid was charred but had evidently been in proper position. The front baffle plate was in position and undamaged except that the small bronze wearing surface at its top was missing, probably as a result of the accident.

In conclusion the report states that there is no direct evidence that there was any defect in the Isothermos journal box assembly at pedestal 4 which was responsible for the heating of the journal. There is, however, direct evidence that the heating was not due to broken dipper, baffle plate or wedge plate out of place, leaking lid gasket, or dirty oil. In spite of the lack of direct evidence, it is possible that the heating was due to loss of oil caused by a loose oil ring.
